Poultry Housing Tips

Understanding Radiant Brooders

Volume 17 Number 1

January, 2005

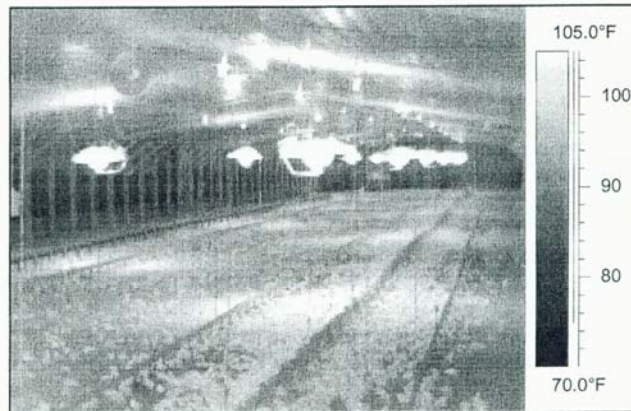
Figure 1. Thermal image of brooding area with radiant brooders.

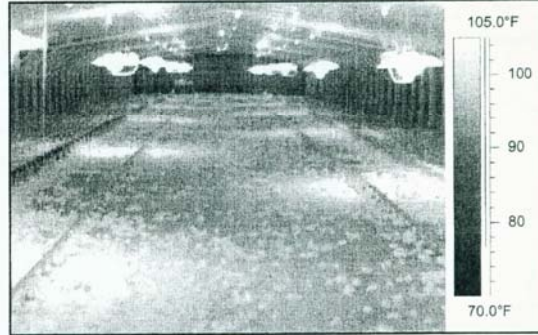
Figure 5. Center of house with chicks.

Figures 4 through 8 were taken on two farms with 40' X 250' curtain-sided broiler houses heated exclusively with radiant brooders during cold weather. Figures 4 and 6 were taken in a house a day prior to chick placement while Figures 5 and 7 were taken in a house the day after the chicks were placed. An air temperature of approximately 90°F was being maintained in all houses when the images were taken. Figures 4 and 5 illustrate floor conditions in the center of the house while Figures 6 and 7 illustrate side wall floor temperatures. In Figures 5 and 7 floor temperatures toward the center of the house ranged between 88°F and 105°F, whereas side wall floor temperatures ranged between 105°F and the low eighties (Figures 6 and 7). As you see in Figures 5 and 7, birds appeared fairly evenly spread out where the floor temperature was in the mid eighties to the high nineties. Birds were noticeably absent from the side walls where floor temperatures dropped to the low eighties.

These figures are a good illustration of the advantage of installing radiant brooders over the feed and water as opposed to directly down the center of the house. With the radiant brooders installed at a height of approximately six feet above the feed and water lines chicks formed large circles over the feed and water. There was feed and water at a range of temperatures within the radiant heat zone of the brooders. The range of floor temperatures in the vicinity of one of the radiant brooders in the house is illustrated in Figures 8 and 9. Though there is a small hot spot

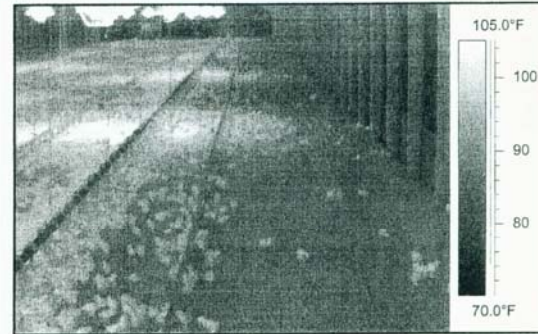
Figure 7. Thermal image near side wall with chicks present.

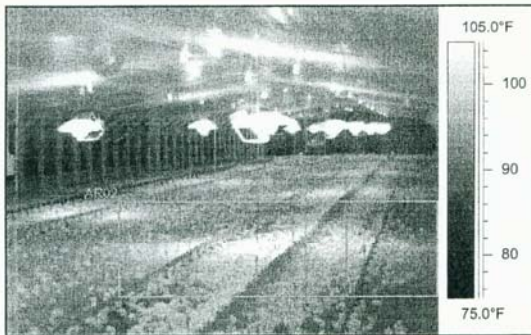
Figure 8. Radiant brooders over feed and water.

directly underneath the radiant brooder it only represents 2.5% of the total area outlined by the blue box in Figure 8. Over 92% of the area of the radiant heat zone of the brooder, indicated by the blue box, was between 90°F and 106°F. The chicks can be seen spreading out throughout the entire radiant heat zone of the brooder, indicating a significant range in temperature preferences.

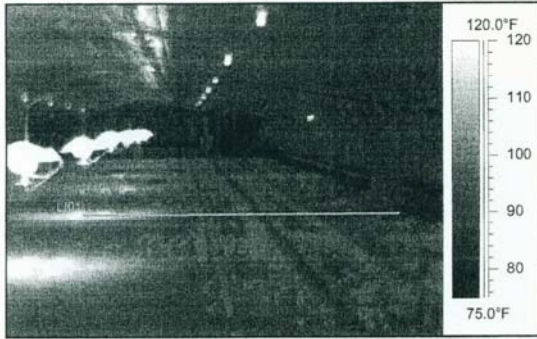
Figure 10. Radiant brooders down center of a house.

Figure 10 was taken in a house with one-week-old chicks where the house temperature was in the low to mid eighties. The house had a number of heating-system-related issues which included: too few radiant brooders, installed down the center of the house and at too low of a height. The fact that there were too few radiant brooders was indicated by the fact that though the outside temperature was in the high thirties the radiant brooders never shut off. The low brooder height, approximately five feet, tended to concentrate all the radiant heat in the center of the house where it was needed the least. This fact can be seen in Figure 11 which illustrates the floor temperature along the blue line in Figure 10. The temperature directly underneath the radiant brooder was approximately 125°F while at the inside water line floor temperature had dropped to a little below 90°F. Floor temperature levels off to the low to mid eighties around the feed line indicating that very little radiant floor heating was taking place. The proof that the brooders were too low was verified by the fact that the chicks were avoiding the center of the house. The proof that the air temperature was too low was that the young chicks were packing into tight groups trying to stay warm from the feed line to the house side water line which was outside the radiant heat zones of the brooders.

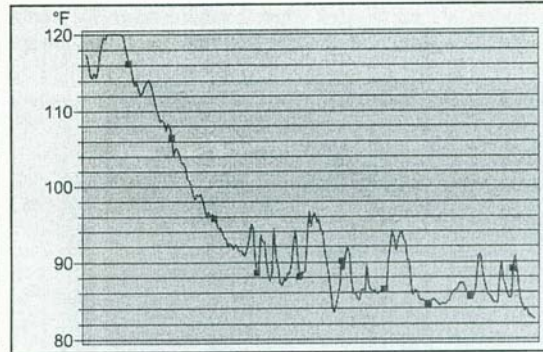
Figure 11. Floor temperature along blue line in Figure 10.

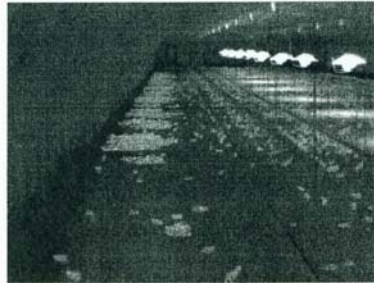
Figure 12. Side wall floor temperatures.

Figures 12 and 13 were taken in a totally enclosed house with five-day-old chicks where an environmental controller was programmed to maintain an air temperature of approximately 86°F (controller sensors were near the feed lines). Chicks appeared very comfortable from about the feed lines to the center of the house where floor temperatures ranged from approximately high eighties to 110°F. Floor temperatures from the feed line to the side wall ranged from the high seventies to the mid eighties and the chicks were showing signs they were chilled. The situation could have been improved by simply increasing the controller setting to 90°F and raising the brooders to a height of six feet. Though this may have lead to overheating the center of the house the overall environment would have probably improved.

Another way to have increased side wall floor temperatures in the house pictured in Figures 12 and 13 would have been to install circulation fans. Circulation fans have proven time and time again to improve floor temperatures in houses using hot air to heat the floor which is in fact the primary method of floor heating near the side walls in houses where radiant brooders are installed down the center of the house. But, the fact remains had the radiant brooders been installed over the feed and water lines the chicks near the side wall would have received a significant amount of radiant heat from the brooders, thus reducing the likelihood that a higher house temperature would have been required.

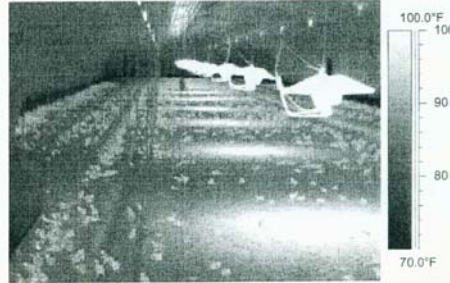
Figure 13. Center house floor temperatures.
